Technical Bulletin

Ref: TB 07001-A
2007

Product: INOcal[®] /INOvent[®]

Monitor failure during High Calibration of the INOvent

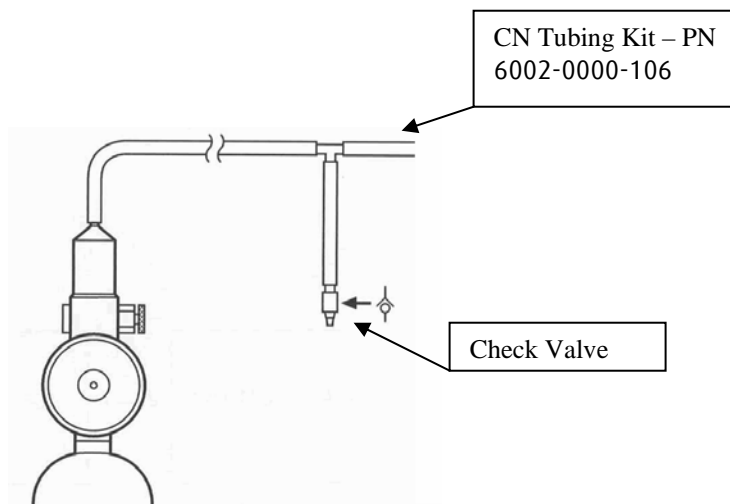
There have been several reports of the water trap bottle becoming dislodged and monitoring failures occurring during the high calibration sequence for the INOvent delivery system. The cause of both issues has been found to be the result of the check valve on the CN Tubing kit being installed backwards. This causes the pressure in the sample system to rise above 70 cm H₂O resulting in dashes on the screen and a subsequent monitoring failure alarm, or in some cases dislodging the water trap. Should either condition be encountered during the high calibration, inspect the CN Tubing kit for the proper placement of the check valve. (See the diagrams below).

The purpose of the check valve, under normal operating conditions, is to vent excess flow and pressure from the sample system and prevent the aspiration of room air in to the cal gas sample.

To correct the problem, remove the check valve from the tubing and reinstall in the proper direction as indicated by the diagram imprinted on the check valve. Keep in mind the direction of gas flow.
