Technical Bulletin

Ref: **TB-07002**

Product: INOcal[®]

Subject: **Old Calibration tubing tee– High Calibration Errors**

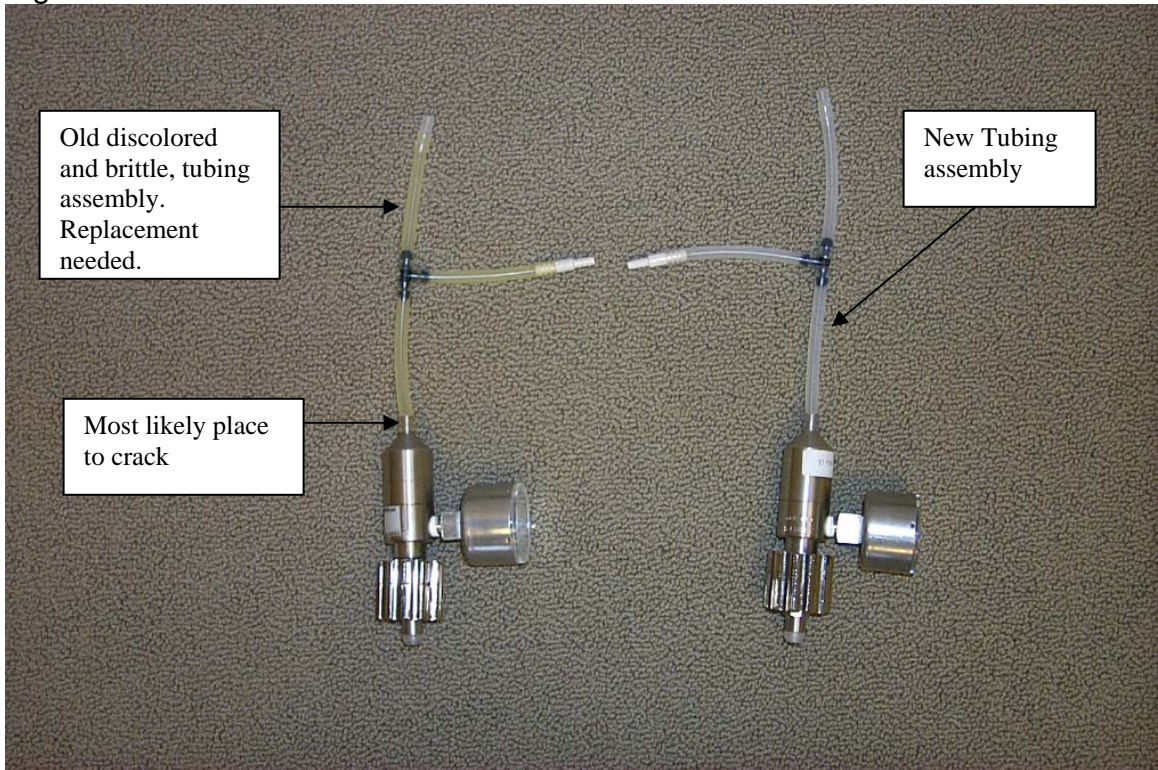
Figure #1

The cause of the erroneous readings has been traced to a leak in the CN tubing kit (p/n# 6002-0000-106) attached to the calibration cylinder regulator. A leak in this tubing will dilute the sample of cal gas going the monitor resulting in the monitor being set to read the monitored value as higher than the actual. This will produce a measured greater than set reading during normal operation.

As the CN tubing kit ages, the tubing becomes discolored, stiff and brittle from long term exposure to the cal gas. The most common place for the tubing to crack is at the point where it attaches to the regulator (see Fig #1 below).

The CN tubing kit should be replaced under the following circumstances:

- The tubing is discolored or stiff
- There is crack or break in the tubing.

Note: A tubing kit with a noticeable crack can be removed from the regulator, trimmed to remove the cracked portion and then reused until a replacement kit can be provided.
