Technical Bulletin

Ref. TB-11001

Product: INOmax[®] DS_{IR} / INOmeter[®]

Subject: INOmax DS_{IR} / INOmeter[®] Infrared (IR) Communication

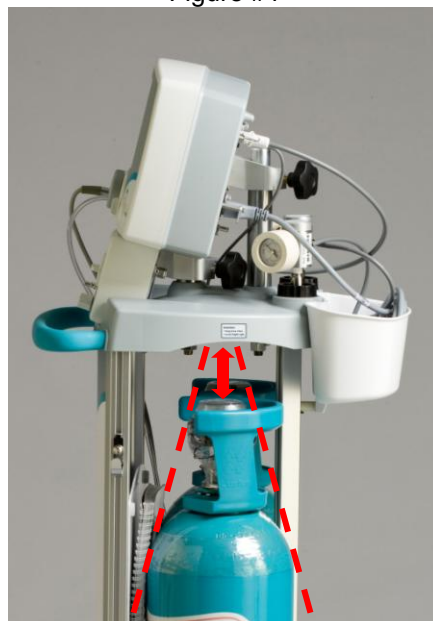
Figure #1

The INOmax DS_{IR} cart has a cover with an infrared transceiver mounted directly above each INOMAX cylinder (see Figure #1). When INOMAX cylinders are loaded, communication will take place between the INOmax DS_{IR} and the INOmeter (after the boot up phase of the INOmax DS_{IR} is complete). A cylinder icon will be displayed on the main screen when an INOMAX cylinder is recognized by the INOmax DS_{IR}.

The INOmax DS_{IR} transceiver transmits via a 30 degree transmission cone projecting towards the floor (see dotted lines in Figure #1). The IR beam is specified to have a range of 20 cm (7.9 in) which should not affect other devices in the vicinity of the INOmax DS_{IR}. The INOmax DS_{IR} cart was designed to protect the INOmeter from external light/IR energy sources. The INOmeter uses a lower energy source which results in a lower IR beam range than the INOmax DS_{IR} cart. The INOmeter does not transmit IR signals unless it mounted on the INOmax DS_{IR} cart.
